NATIONAL TRANSPORTATION SAFETY BOARD
Office of Aviation Safety
Washington, DC 20594

SURVIVAL FACTORS GROUP CHAIRMAN'S ADDENDUM #1

February 7, 2014

| NTSB # | : | DCA13MA120 |

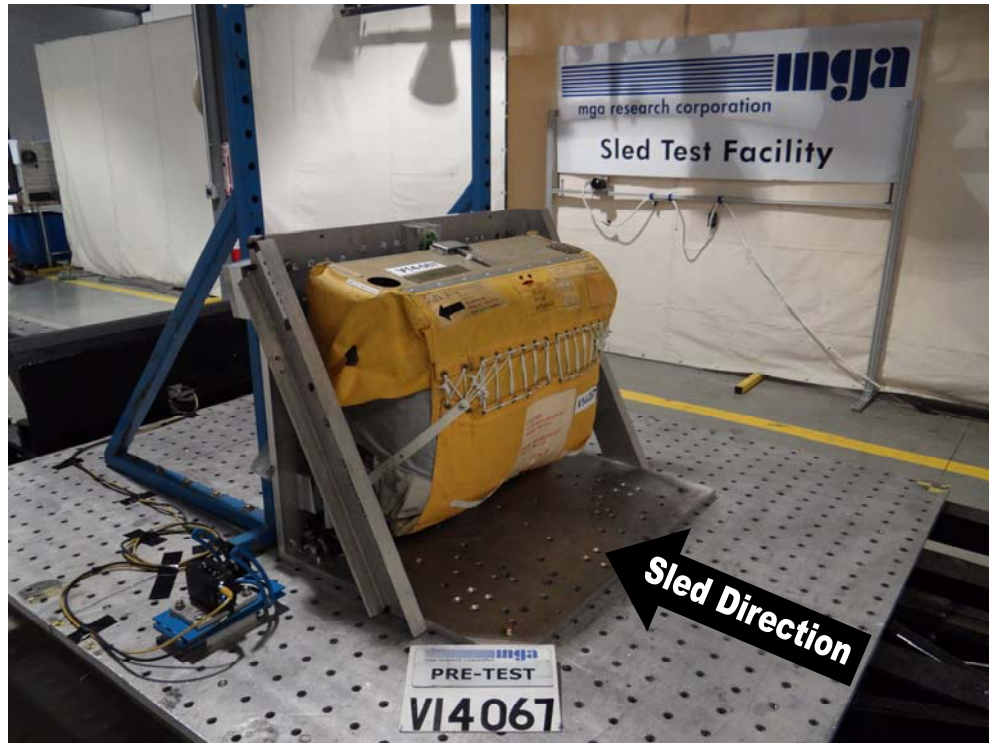
The first test was conducted with the slide/raft pack positioned for an inboard load (photo 1). The test consisted of 7 accelerated sled runs. No damage was noted on the first six runs. The slide/raft pack released on the 7th run after 99ms at an acceleration of 14.4g. The unit was examined in detail. The aft aspirator strap released. High-speed video of the test indicated that the release shaft did not rotate prior to the separation of the aspirator strap (see attachment 2). Seven of the 8 release cable balls (photo 2) separated from their respective cables that they were swaged to which allowed the valise to partially open and the slide/raft pack to release. The pin shields were removed and no witness marks from the release cable balls were observed. The release mechanism was removed from the packboard in order to observe the release shaft and tang. Neither the tang nor the release shaft was damaged.

Photo 1. Slide/raft pack positioned for inboard load

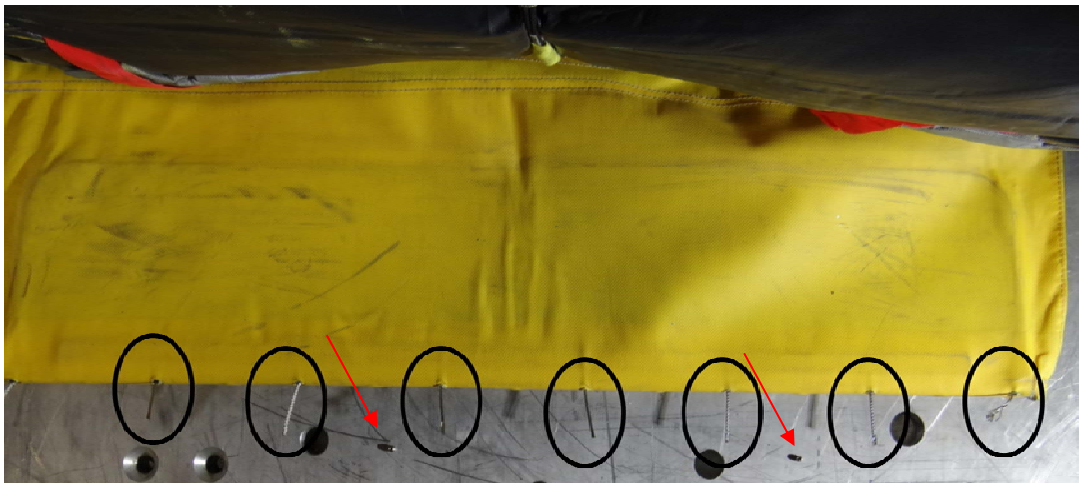
Photo 2. Seven damaged packboard release cables and two separated cable balls

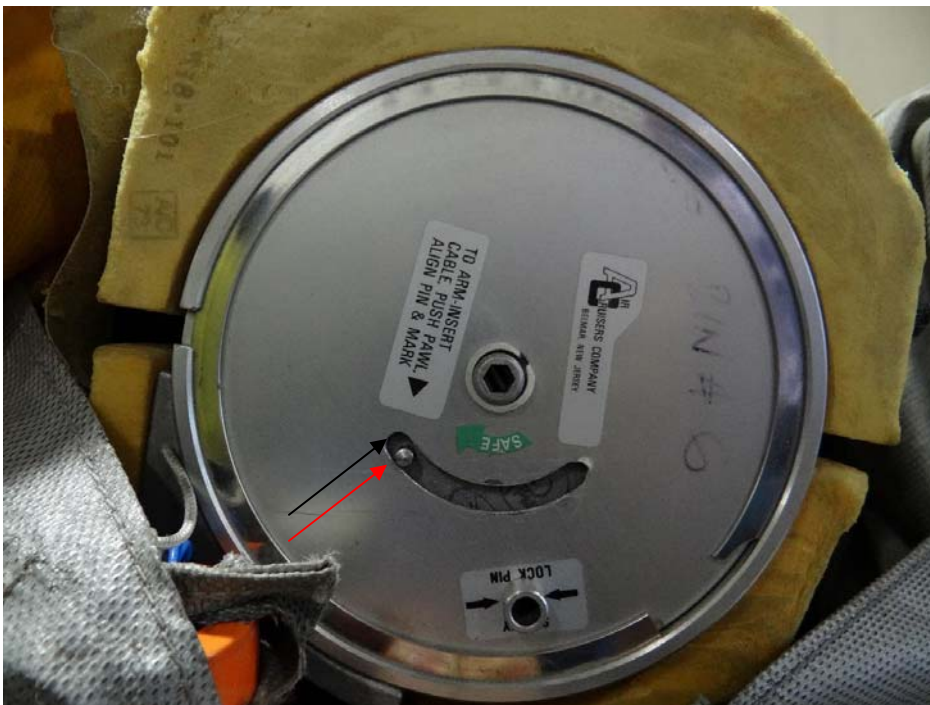
The second test was conducted with the slide/raft pack positioned for an inboard load. The test consisted of 1 accelerated sled run and the slide/raft pack released after 86ms at an acceleration of 14.2g. The unit was examined in detail. Both aspirator straps had released. High-speed video of the test indicated that the release shaft did not rotate prior to the separation of the aspirator straps. High-speed video also showed that, after the release of the aspirator straps, the inflatable slide/raft came completely off the packboard and traveled inboard until the girt was taut. When braking was applied to the sled, the slide/raft rebounded and settled next to the packboard. It did not unfold. Seven of the 8 release cable balls separated from their respective cables that they were swaged to which allowed the valise to open and the slide/raft pack to release. The pin shields were removed and no witness marks from the release cable balls were observed. The release mechanism was removed from the packboard in order to observe the release shaft and tang. Neither the tang nor the release shaft was damaged. It was noted that the pulley mechanism inside the inflation valve had moved slightly and a safety pin could no longer be inserted into the valve (photo 3).

Photo 3. Slide/raft inflation valve (red arrow indicates final position of pulley indicator; black arrow shows the indicator's original position)

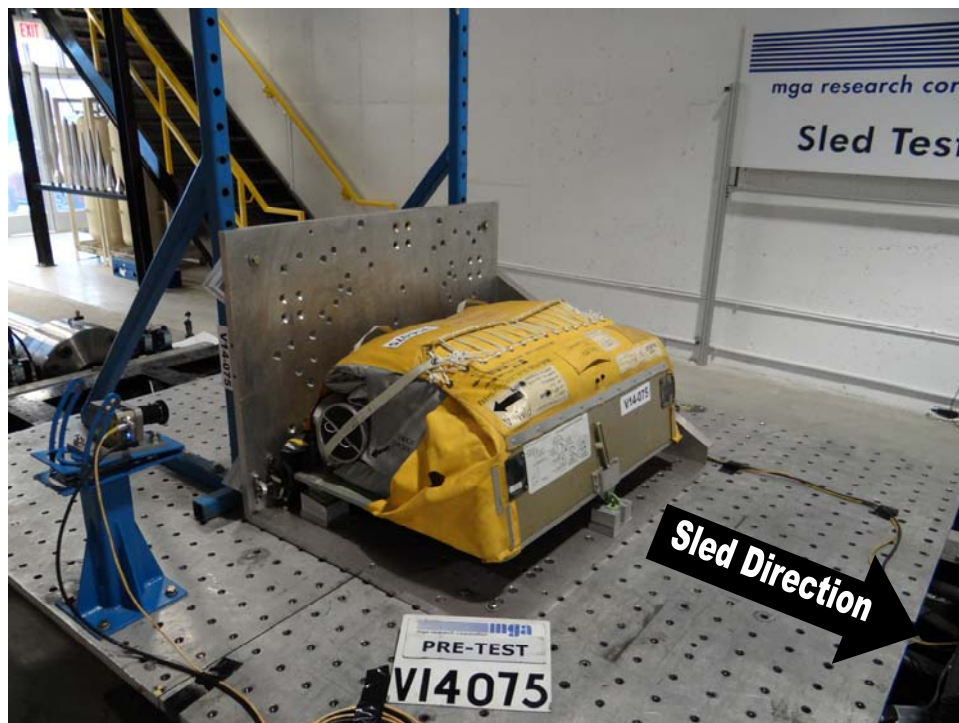
The third test was conducted with the slide/raft pack positioned for a downward load (photo 4). The test consisted of 4 accelerated sled runs. The slide/raft pack released on the 4th run after 94-96ms and 12.7-12.9g. The unit was examined in detail. Both aspirator straps had released. High-speed video of the test indicated that the release shaft rotated between 94-96ms. All 8 of the release cables released from the packboard and the release cable balls were intact. The release cables all had a noticeable curl. The pin shields were removed for examination and witness marks from the release cable balls (photo 5) were observed. The release mechanism was removed from the packboard to observe the release shaft and tang. The tang had torn the release shaft (photos 6 and 7) resulting in similar damage to that documented on the slide/rafts from doors 2R, 3R and 4R of the accident airplane.

Photo 4. Slide/raft pack positioned for downward load

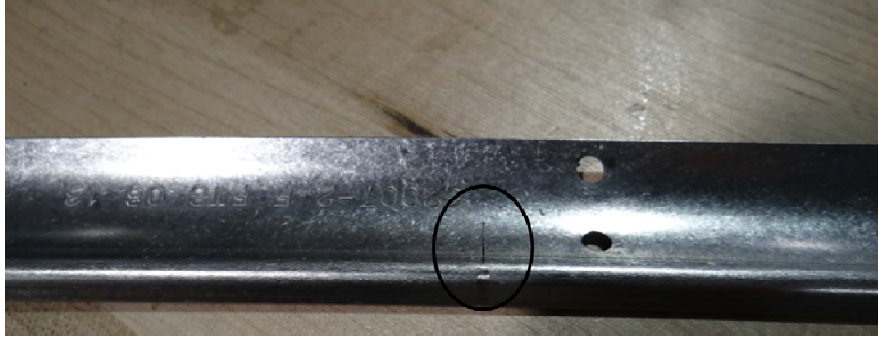
Photo 5. Pin shield witness mark

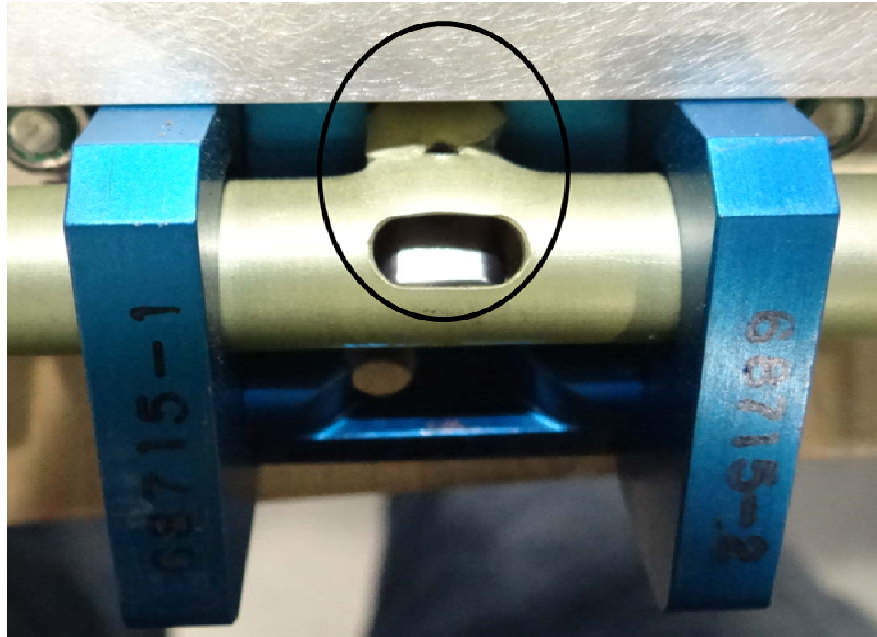
Photo 6. Packboard release mechanism with torn release shaft

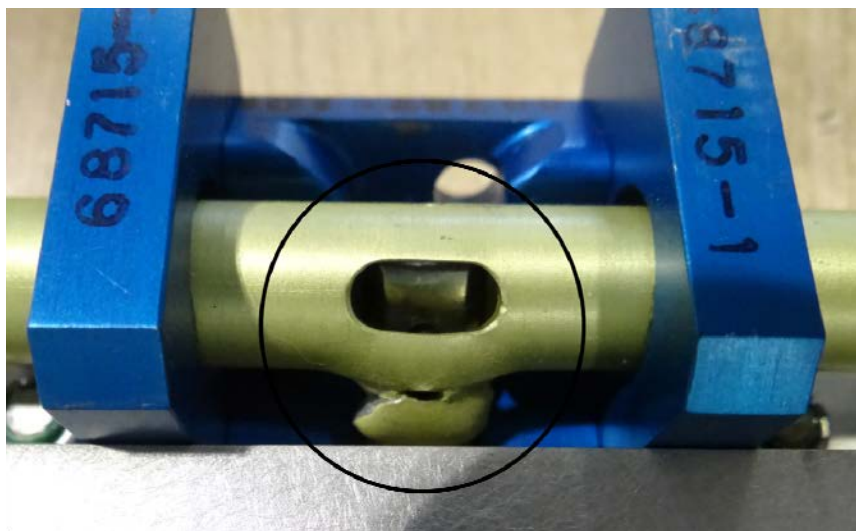
Photo 7. Packboard release mechanism with torn release shaft

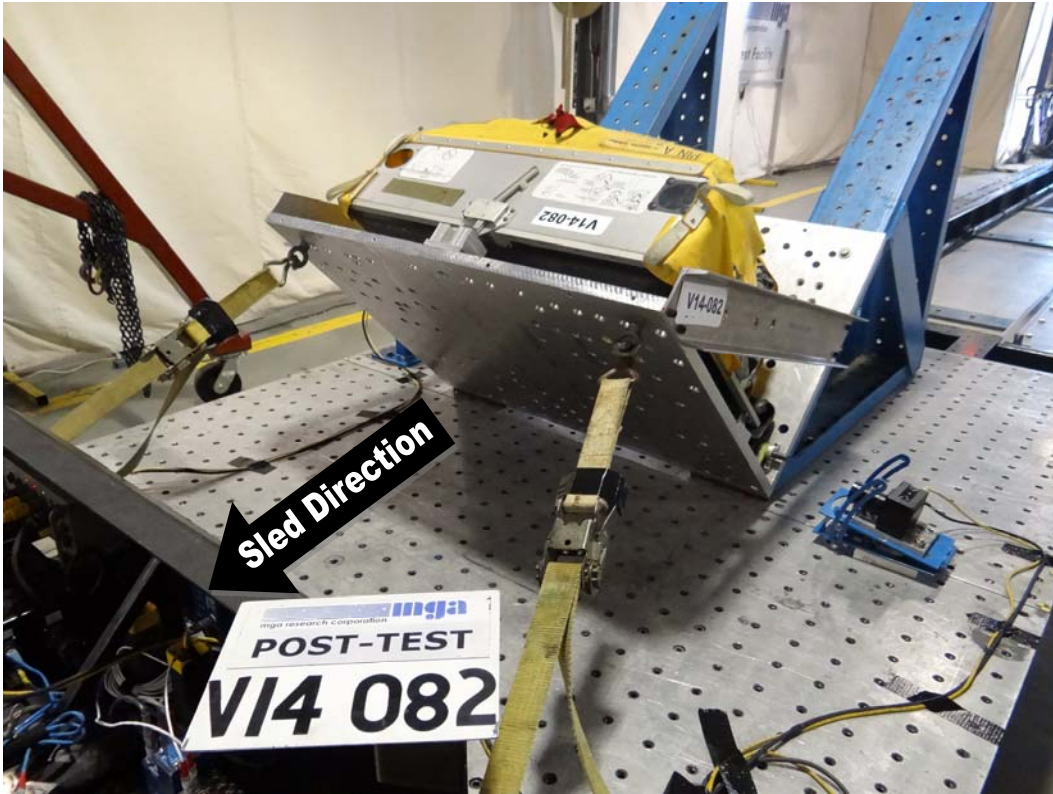
The fifth test was conducted with the slide/raft pack positioned for a 45 degree/combined inboard & downward load (photo 8). The test consisted of 3 accelerated sled runs. The slide/raft pack released on the 3rd run after 90ms and 12.4g. The unit was examined in detail. Both aspirator straps had released. High-speed video of the test indicated that the release shaft rotated at 101ms. All 8 of the release cables released from the packboard and the release cable balls were intact. The release cables all had a noticeable curl. The pin shields were removed for examination and witness marks from the release cable balls were observed. The release mechanism was removed from the packboard to observe the release shaft and tang. The tang had torn the release shaft resulting in similar damage to that documented on the slide/rafts from doors 2R, 3R and 4R of the accident airplane and acceleration sled tests #3 and #4.

Photo 8. Slide/raft pack positioned for 45 degree combined inboard/downward load

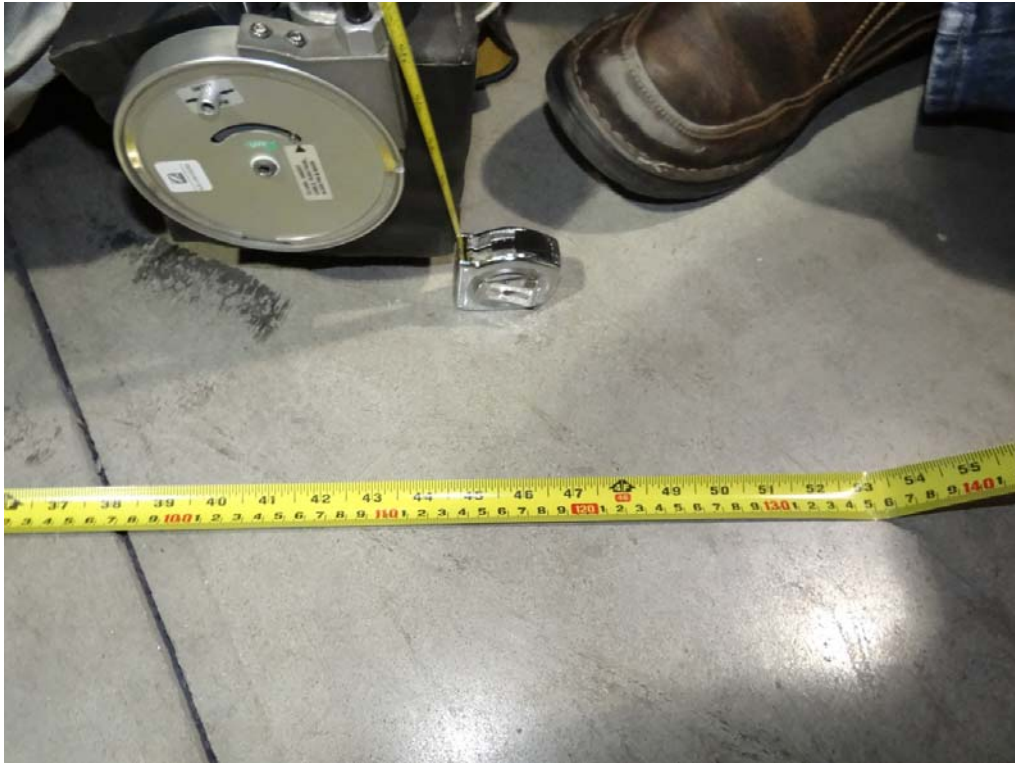
In an effort to obtain a measurement of how far the slide/raft would have to move to initiate the inflation process after release from the packboard, a slide/raft pack was intentionally released from the valise cover and laid on the floor as if the top of the pack had fallen inboard. Measurements were then recorded of the distances between the girt bar and the center of the inflation valve and of the inflation cable itself. The distance between the girt bar and the center of the inflation valve measured 40.5 inches (photo 9). The length of the inflation cable from the girt grommet to its insertion point in the inflation valve measured 60.5 inches (photo 10).

Photo 9. Measurement from girt bar to center of closed inflation valve

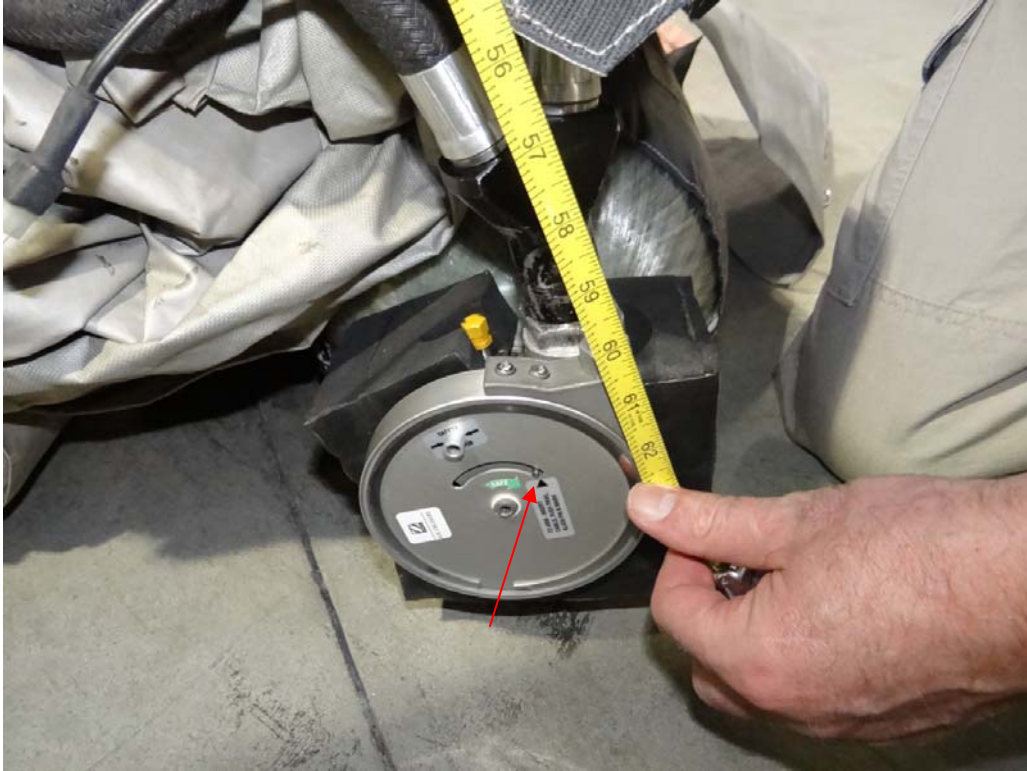
Photo 10. Measurement of the inflation cable with valve in the closed position

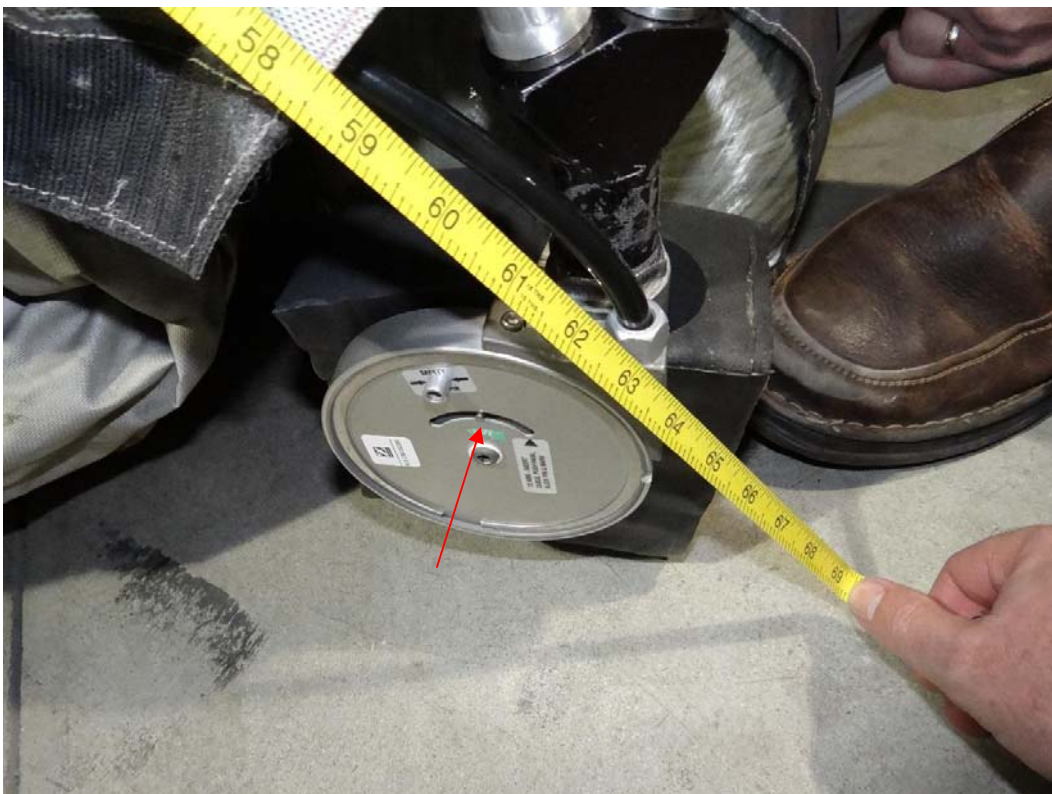
would have to travel before inflation occurred. The distance between the girt bar and the center of the inflation valve at the time of inflation cable release measured 47 inches, meaning that the pack traveled 6.5 inches prior to release. The length of the inflation cable from the girt grommet to its insertion point in the inflation valve measured 63.5 inches after inflation cable release.

Photo 11. Measurement of the inflation cable with valve in the half open position
